CP2007 - Lea Hill Rd Bridge Deck Preservation Vicinity Map

BRIDGE INSPECTION REPORT

Bridge No. AUBURN19

Bridge Name LEE HILL BRIDGE

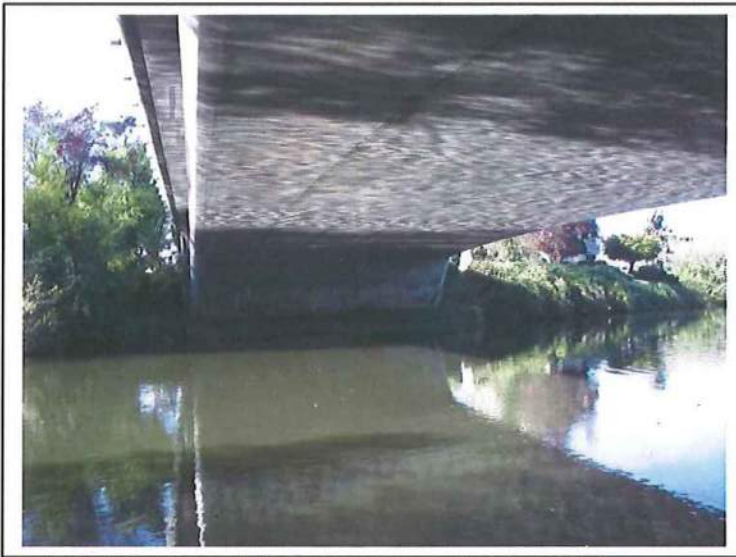
Looking south to
abutment 1.

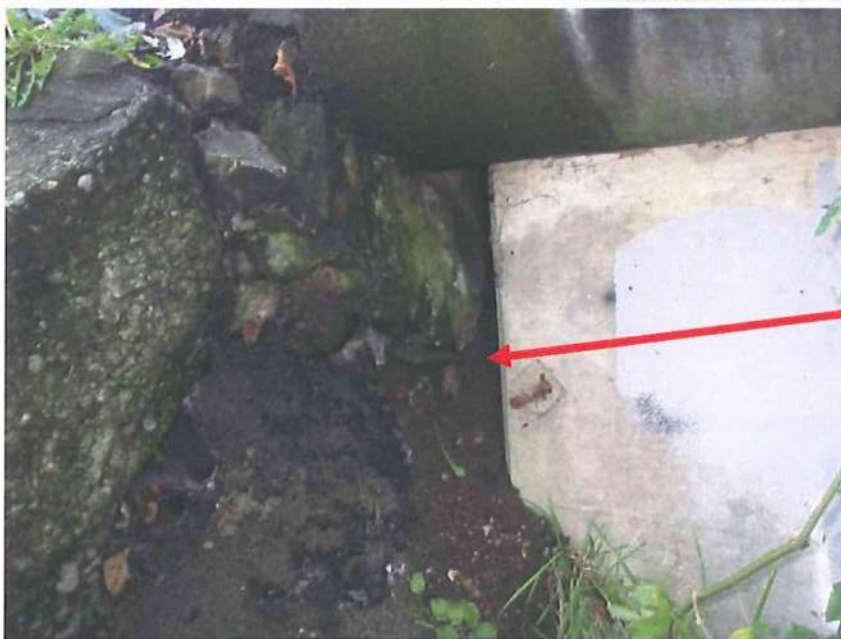
SW corner abutment sloughing
corner.

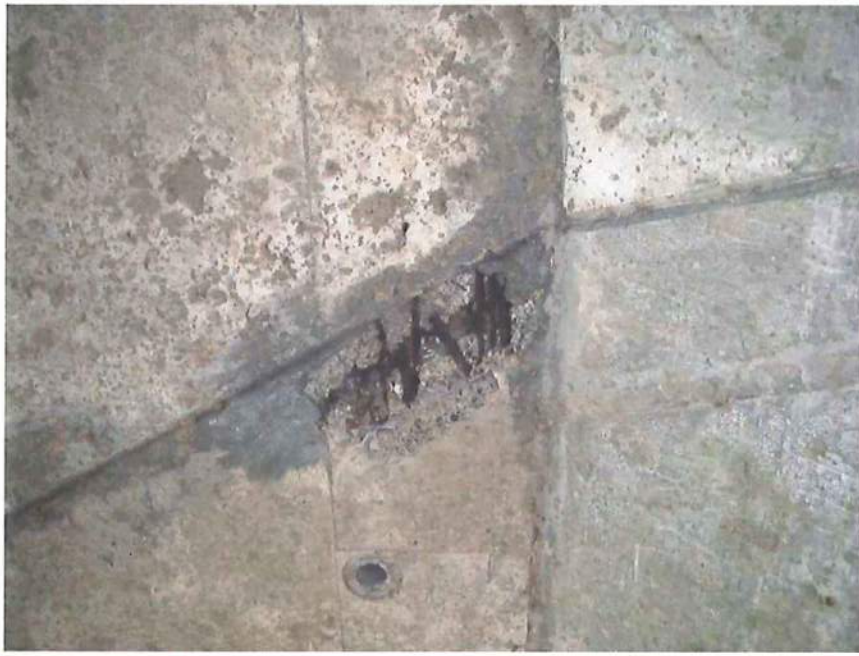
Spall with exposed rebar
NE corner in soffit.

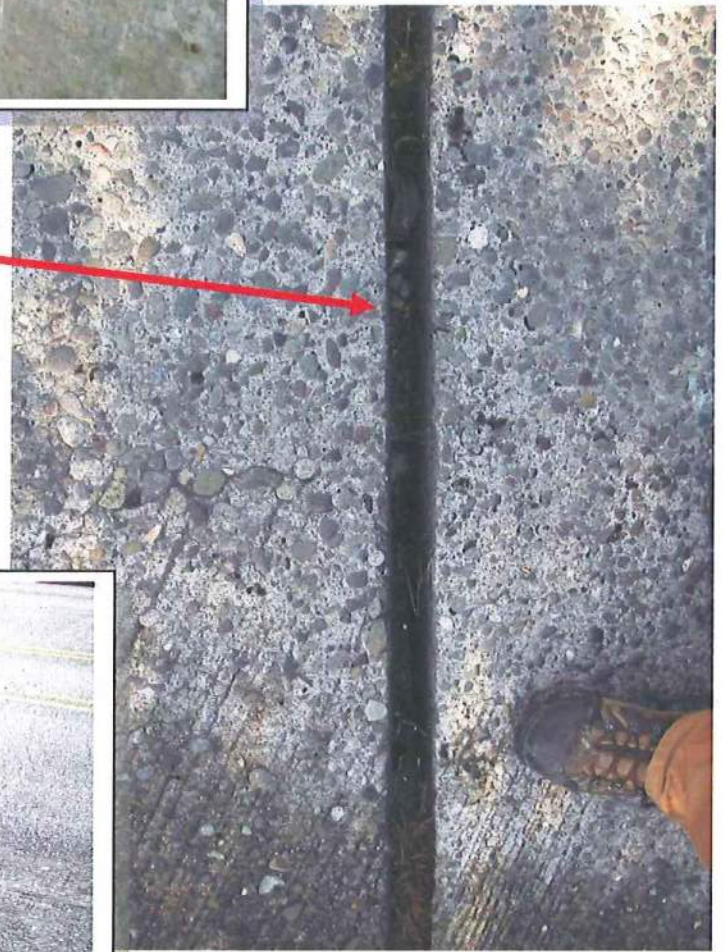
Missing seal south
approach joint.

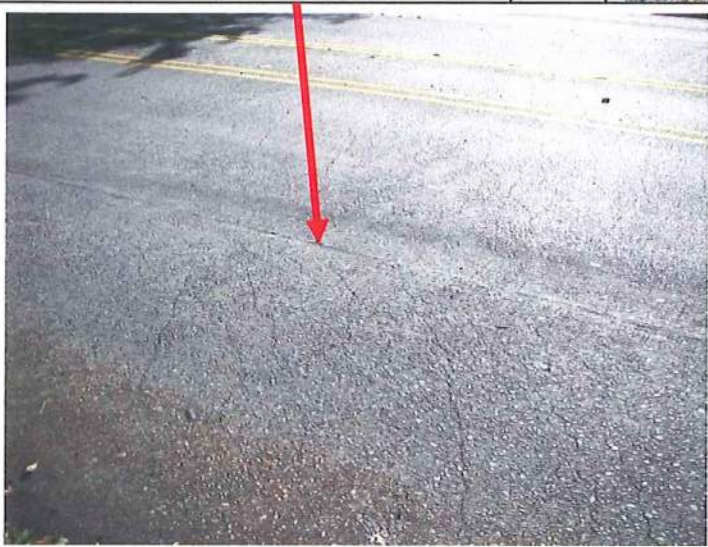
Diagonal and transverse
cracking throughout deck
surface.

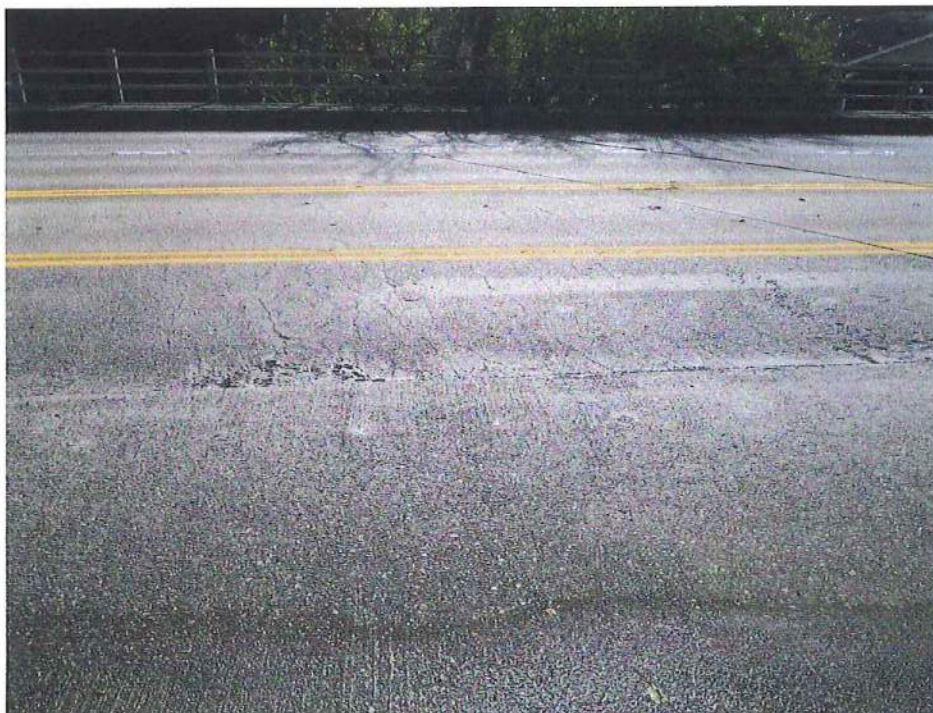
AUBURN19 DECK CRACKING

Numerous cracks and some spalling
westbound lane mid span

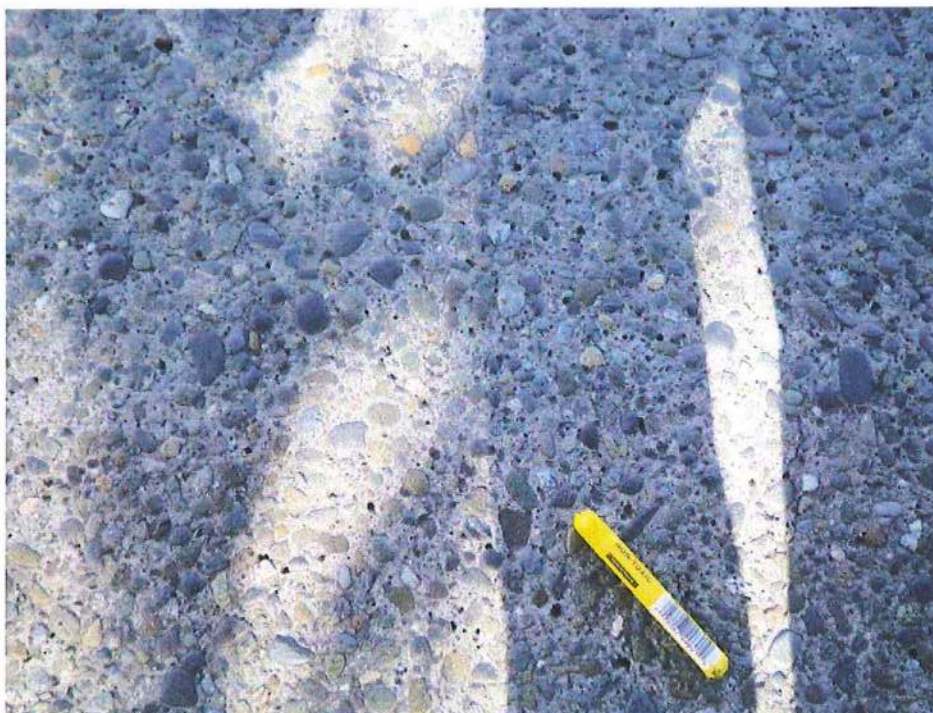
AUBURN19 DECK SCALING

Scaling throughout deck surface
photo at SE corner

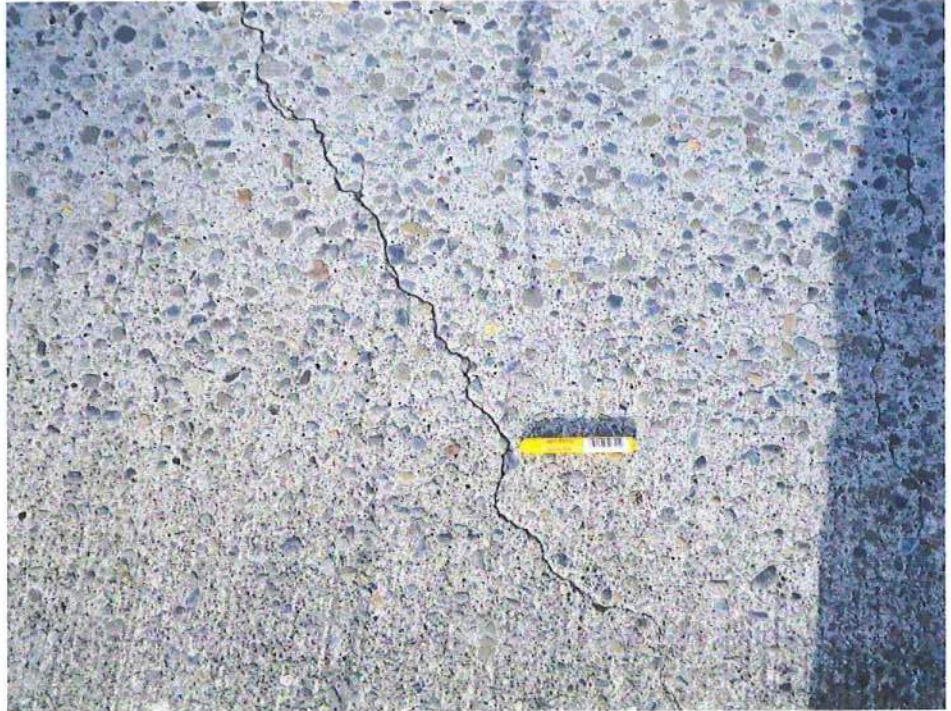
Open crack SW end of deck surface

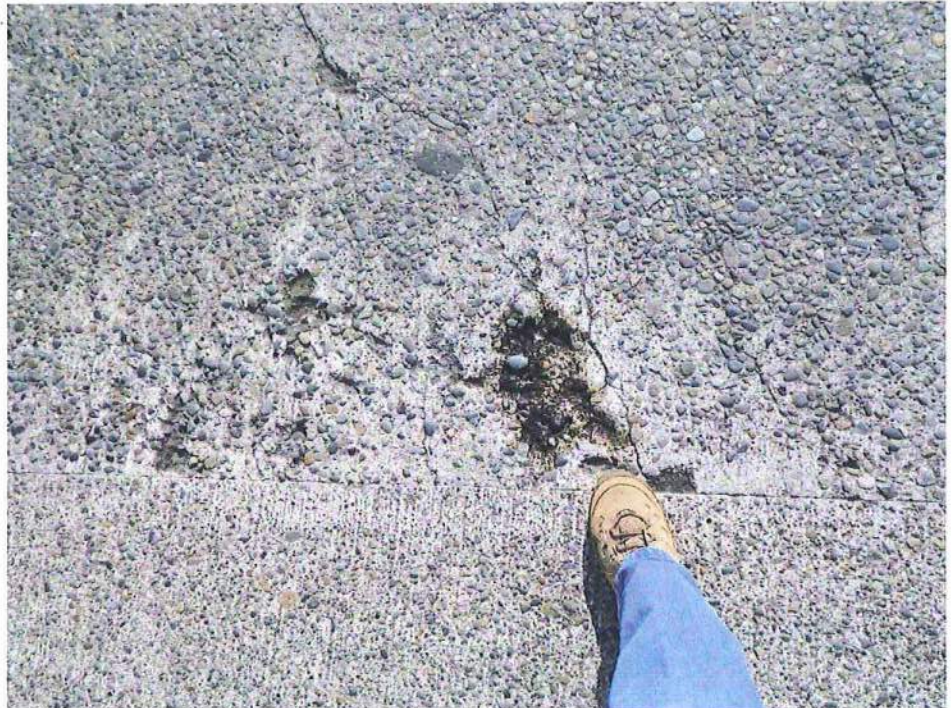
AUBURN19 DECK

Spall mid westboun lane

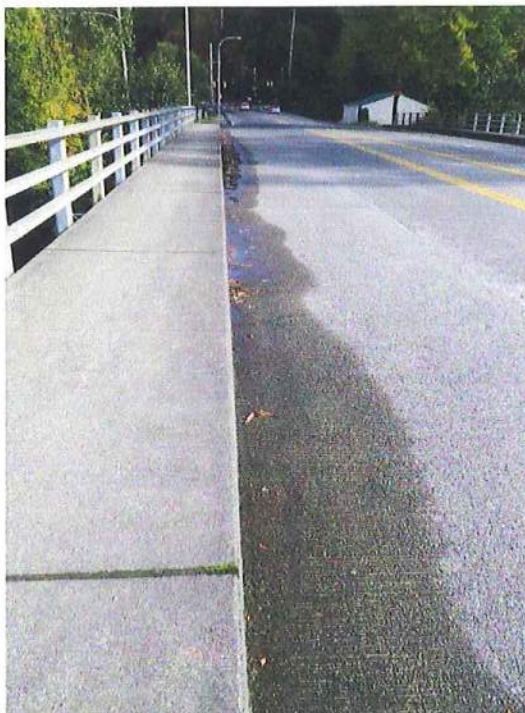
Ponding areas along both north and south curb

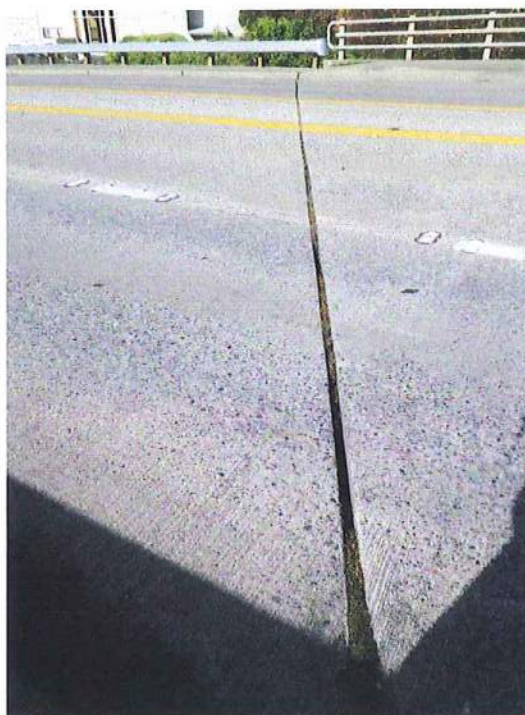
AUBURN19 JOINT W APPROACH

West approach slab joint no seal

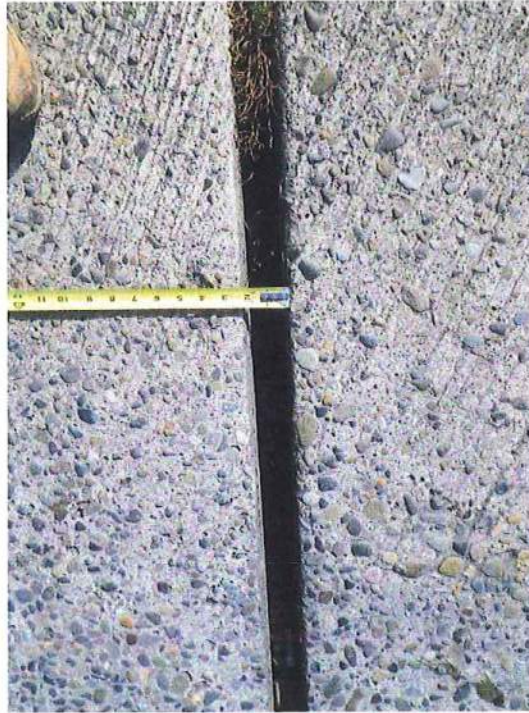
West approach slab to deck no seal
in place

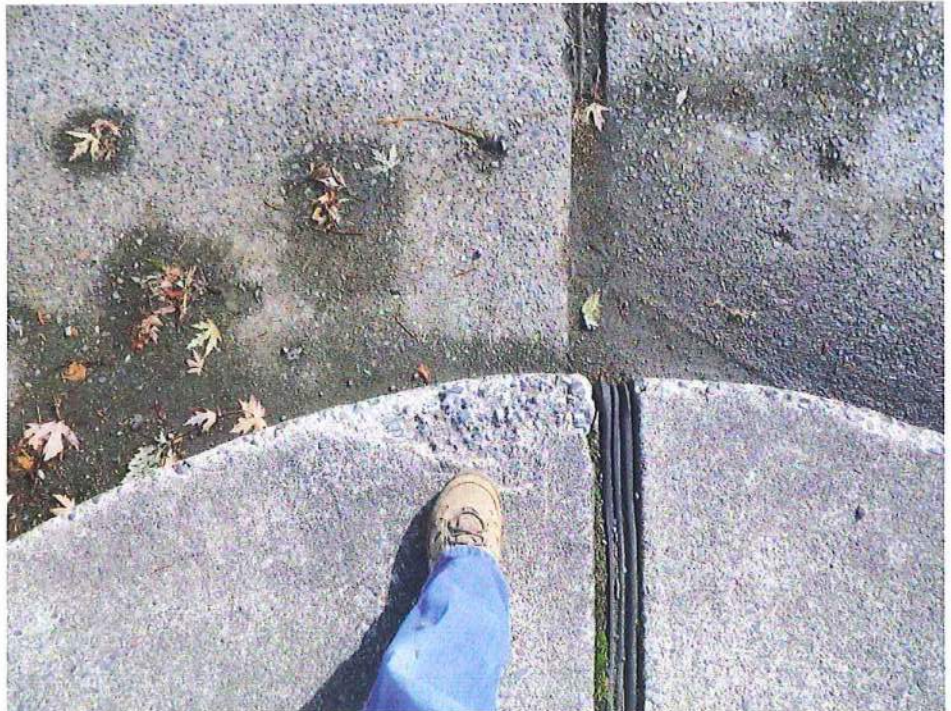
AUBURN19 CURB

NE corner curb spalls

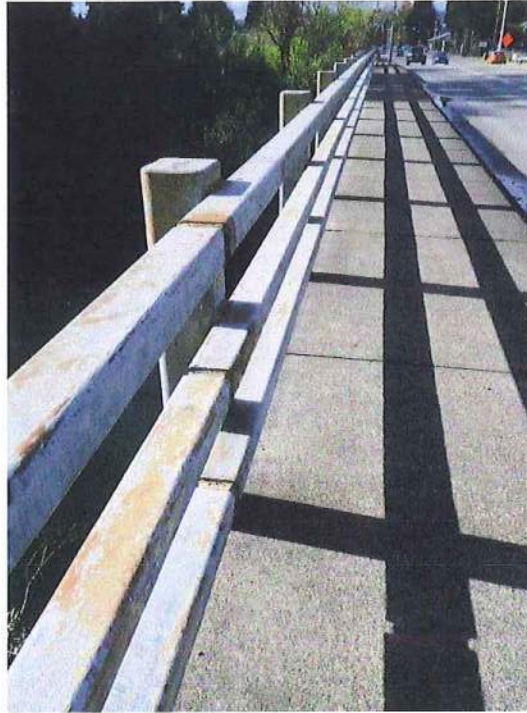
Failing paint on metal bridge rail

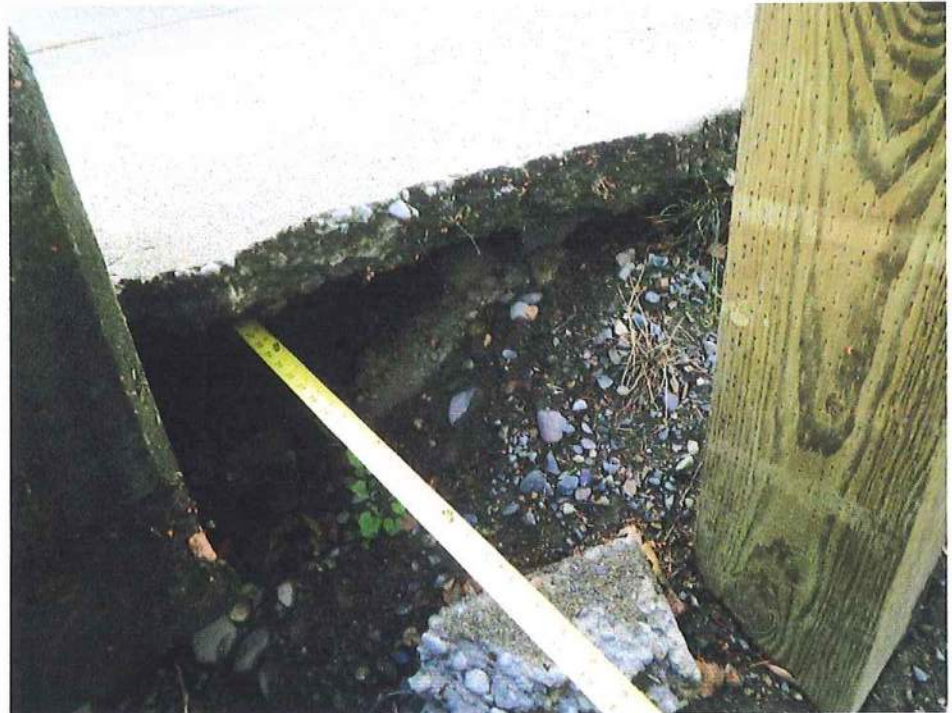
AUBURN19 SIDEWALK NW CORNER

Undermined at bridge deck

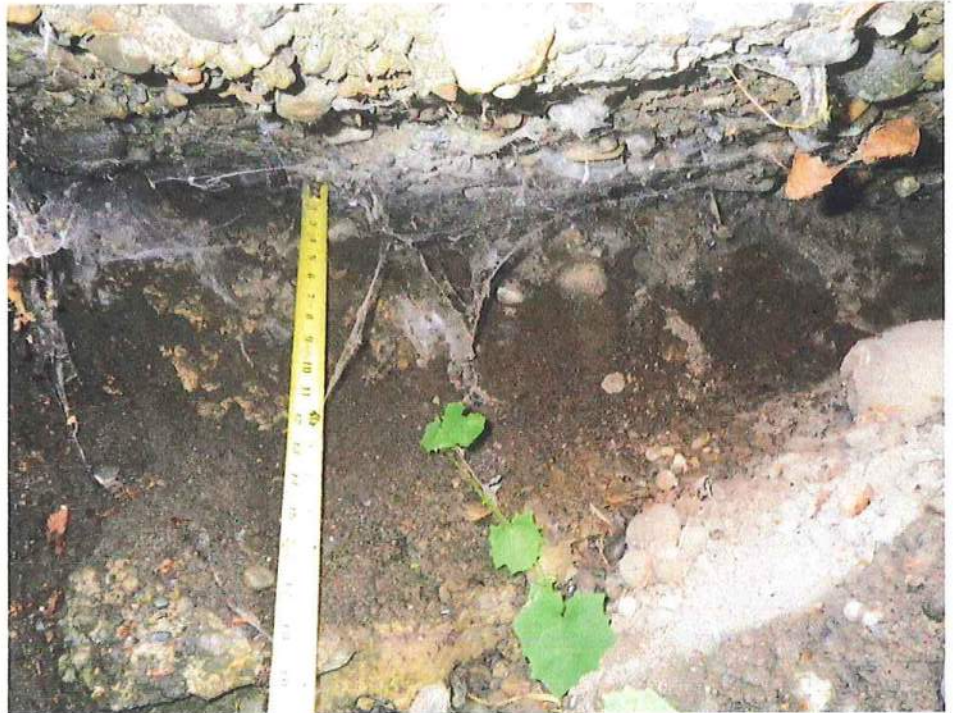
Underminded 24"

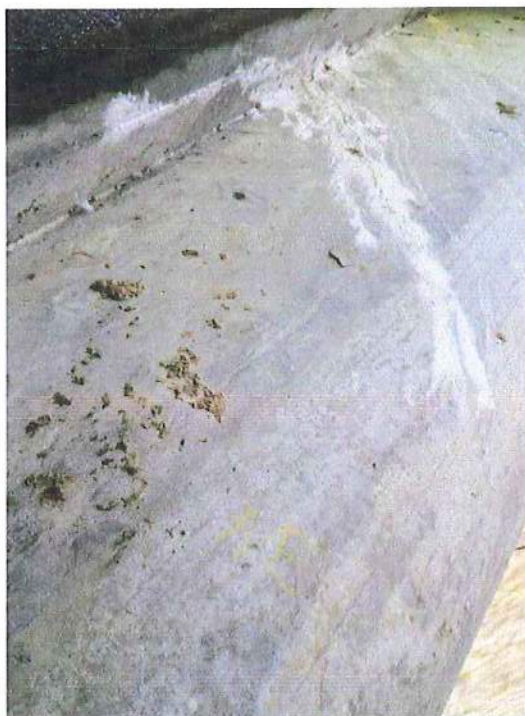
AUBURN19 ABUT 2

Leaching crack NE corner abutment

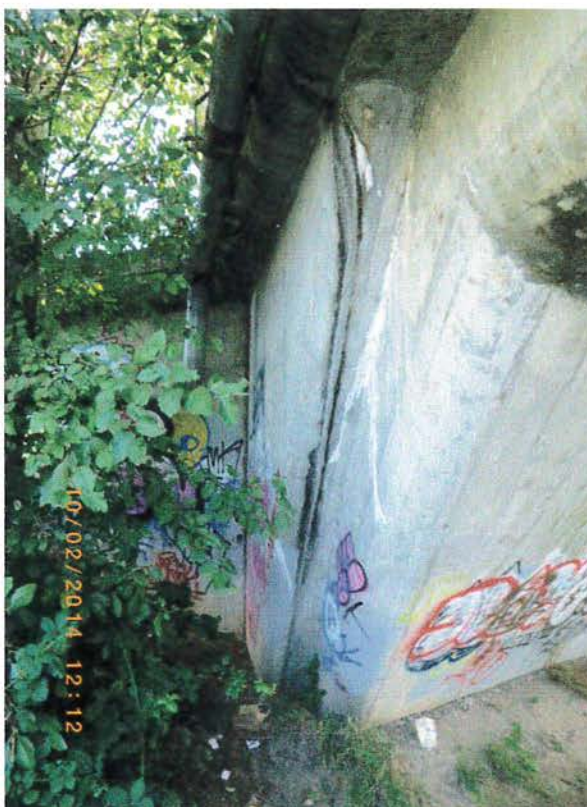
AUB-19 ABUT 2 WEST FACE

LEACHING CRACKS

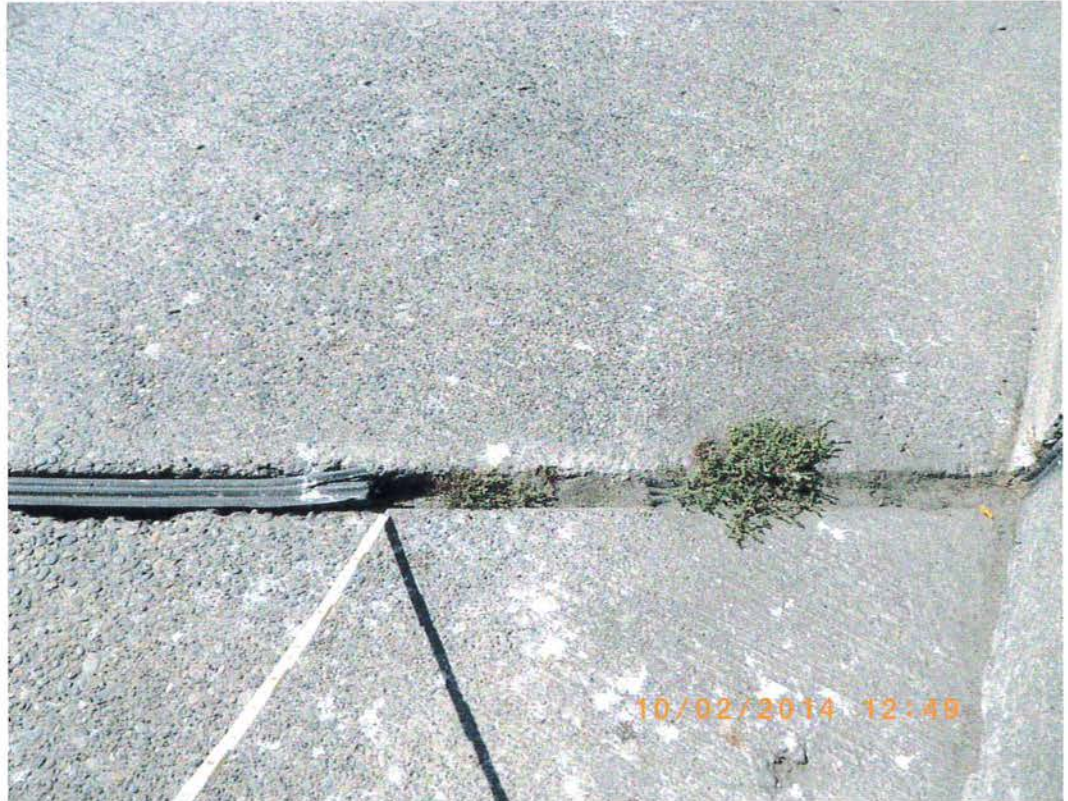
SECTION OF SEAL MISSING

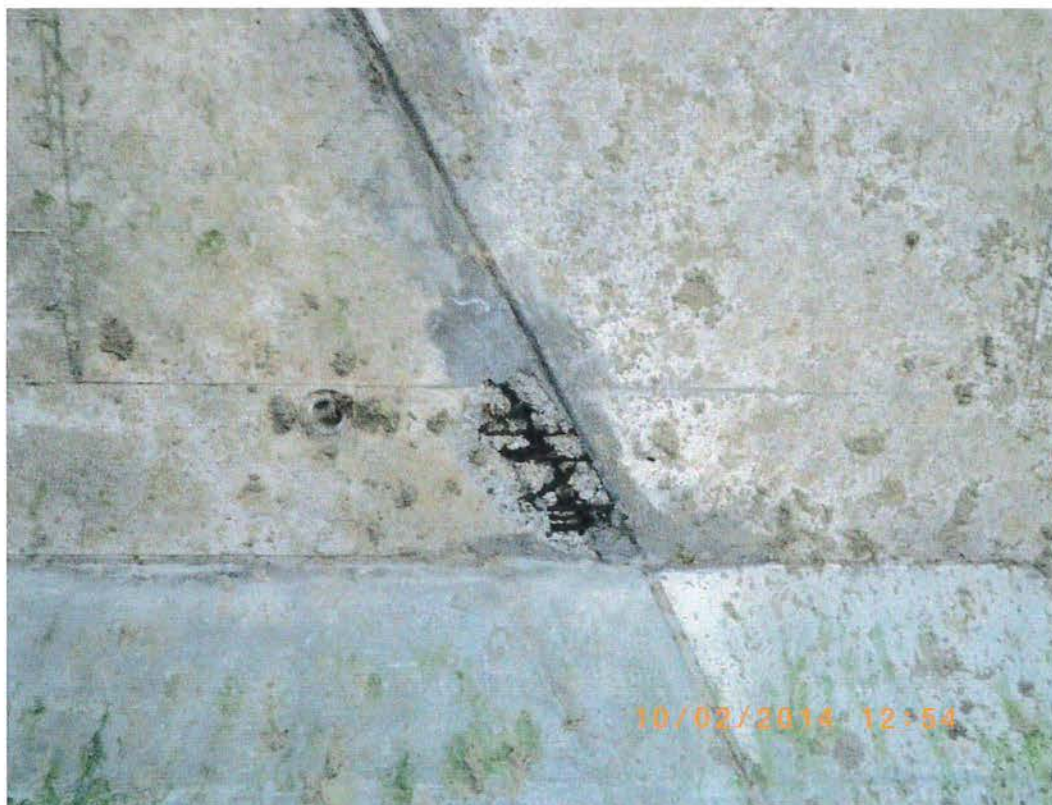
AUB-19 SOFFIT WITH SPALL

AND EXPOSED REBAR NE

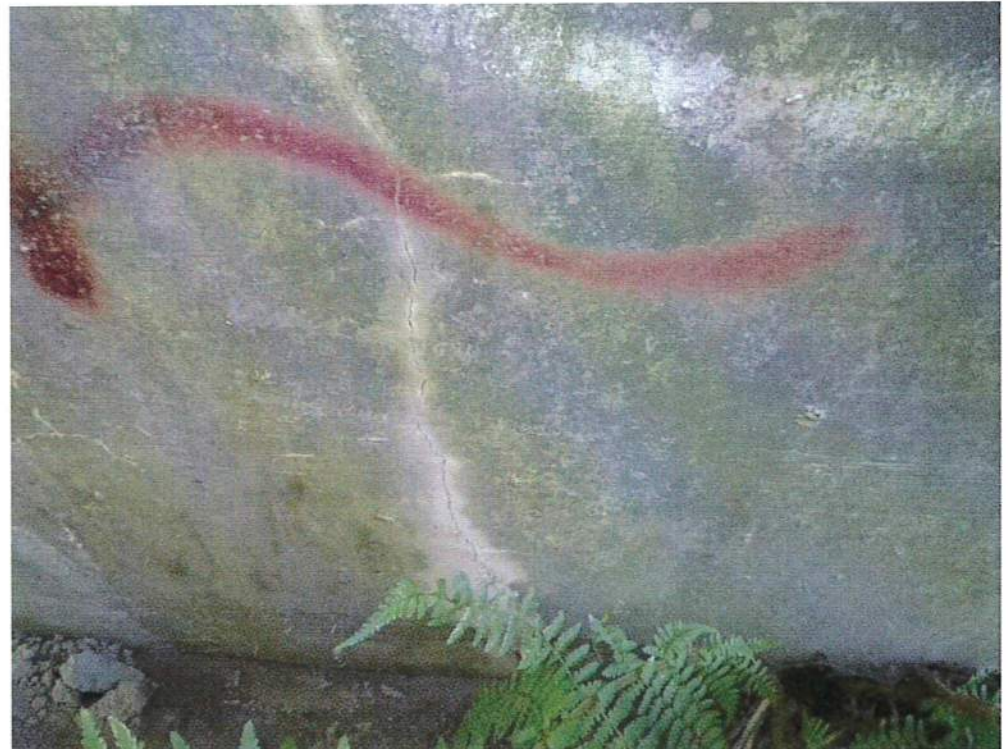
PHOTO: AUB-
19_10-16-
2018_HP (23)
ABUT1 VLC

REMARKS: Vertical leaching crack in
abutment wall

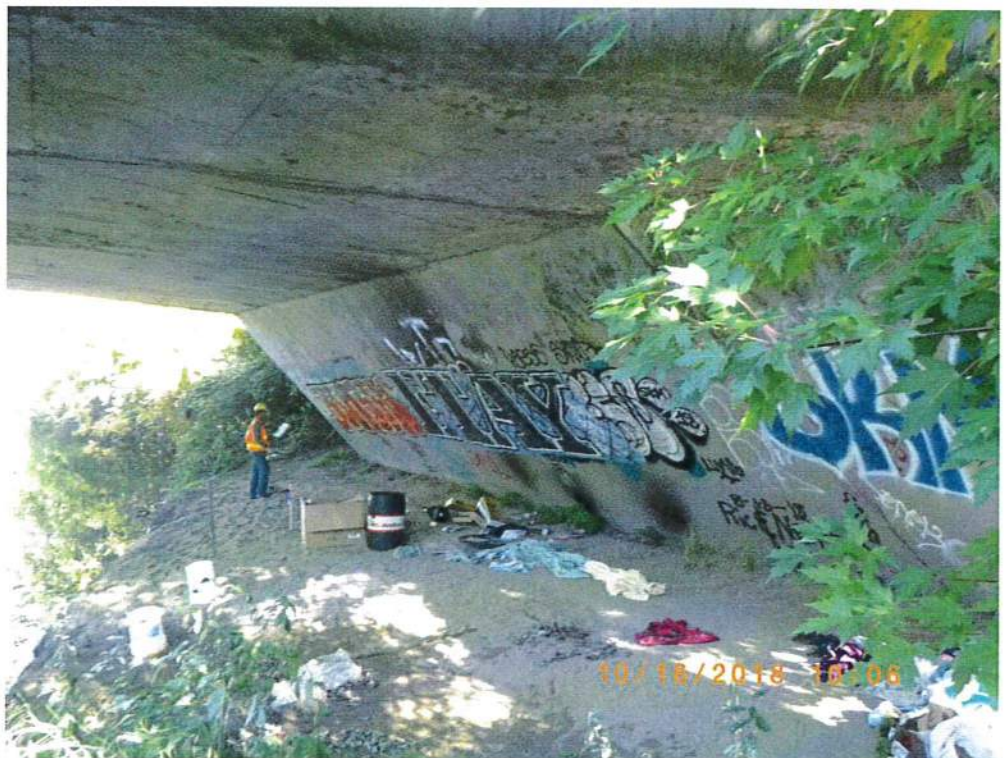
PHOTO: AUB-19
10-16-2018 MAG
(43) ABUT 2
GARBAGE

REMARKS: Graffiti and garbage

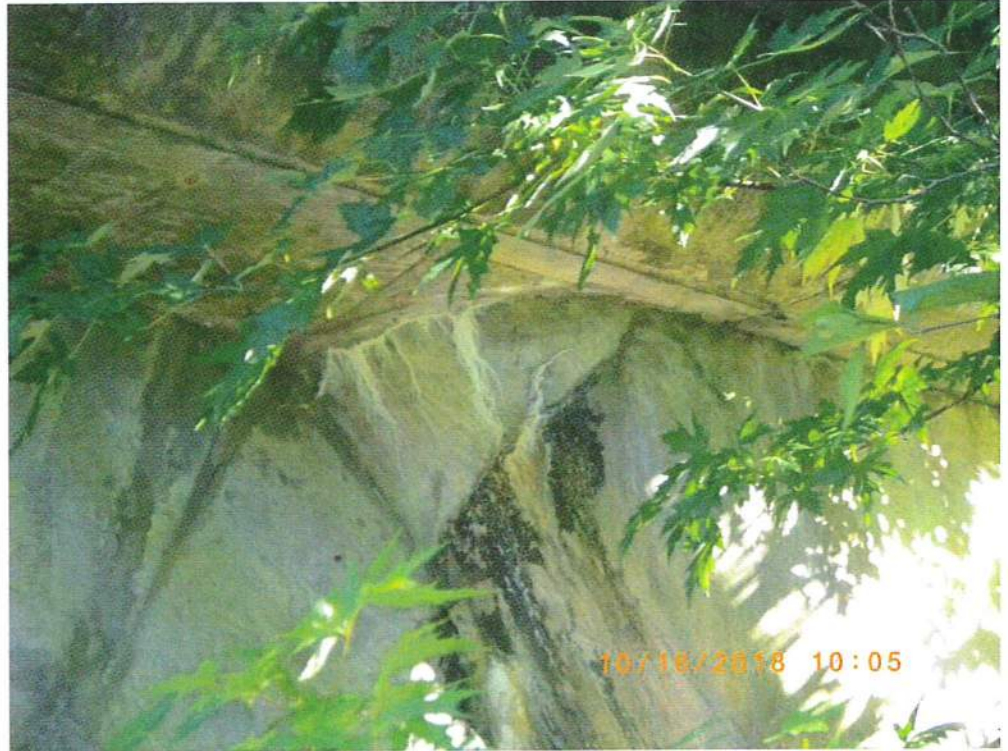
PHOTO: AUB-19
10-16-2018 MAG
(42) CRACK
ABUT 2 NE

REMARKS: Leaching crack at top NW
corner of abutment - retaining wall
interface

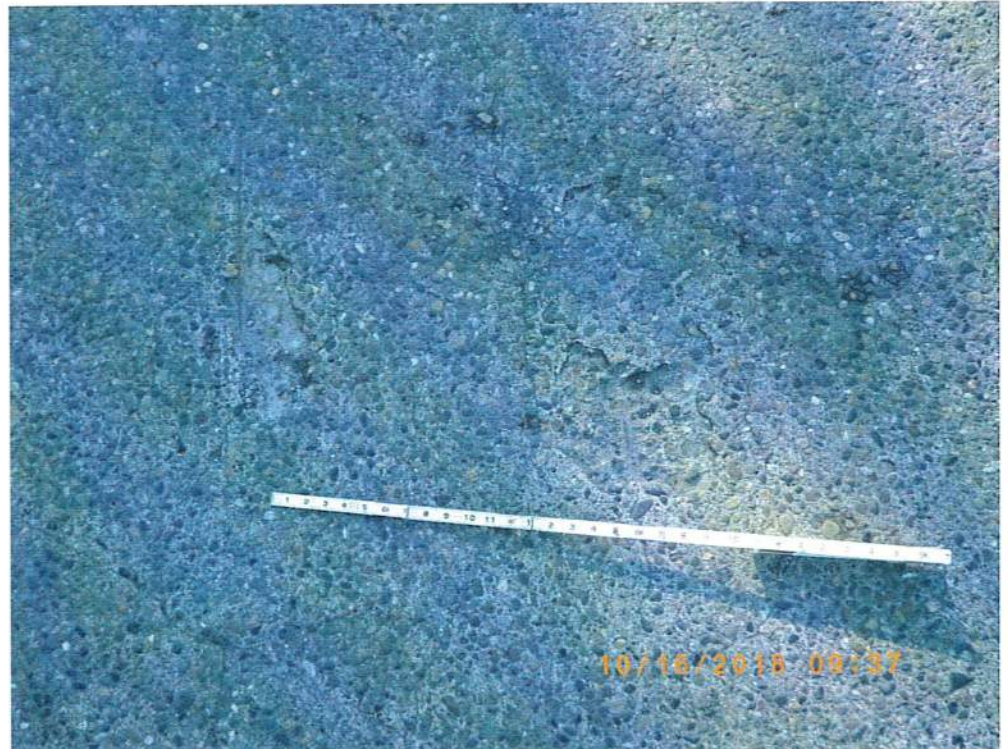
PHOTO: AUB-19
10-16-2018 MAG
(6) DECK
SCALING

REMARKS: Area of scaling with exposed
rebar

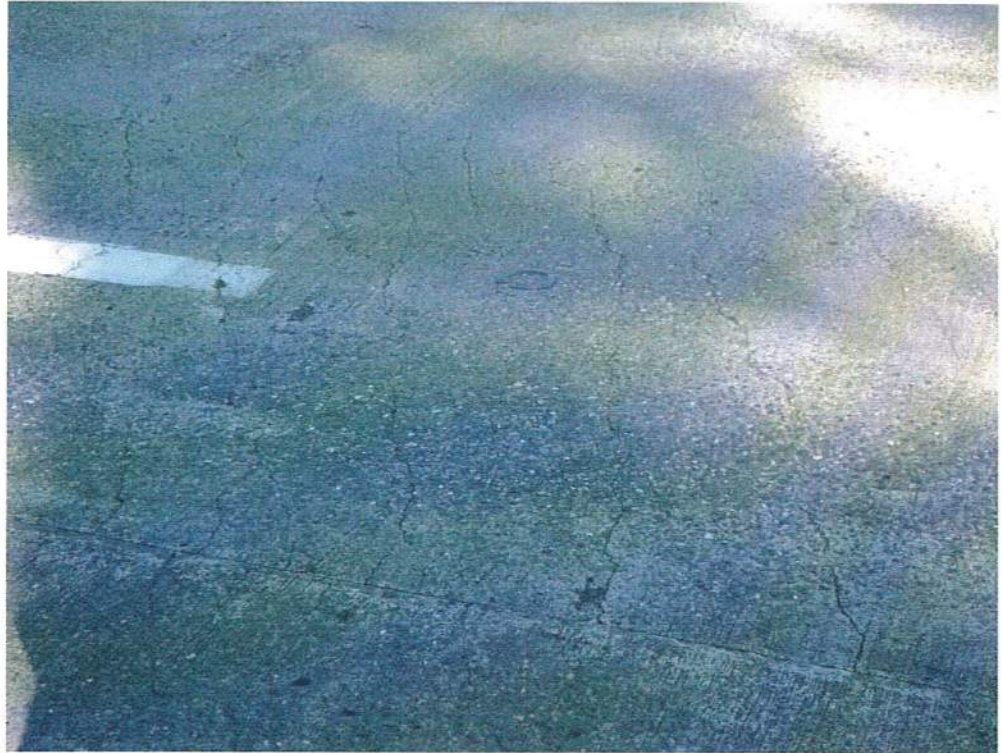
PHOTO: AUB-19_10-16-2018_HP (39)
DECK CRACKS

REMARKS: East end of EB lane
widespread cracking typical

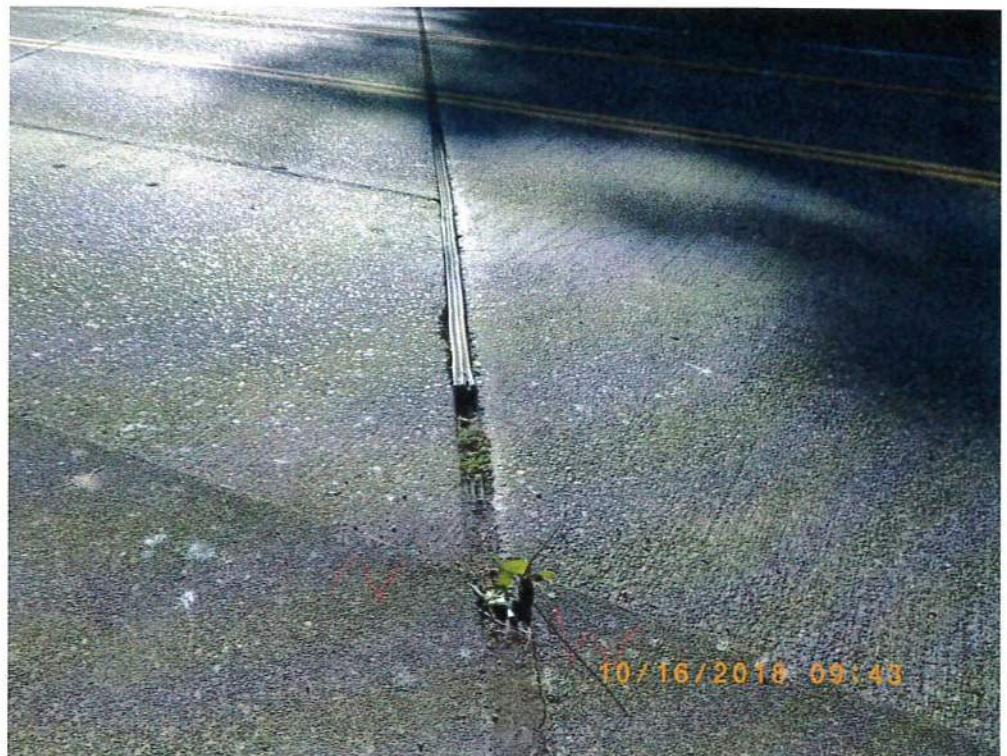
PHOTO: AUB-19_10-16-2018_MAG (14)
JOINT W

REMARKS: Compression seal with
missing section

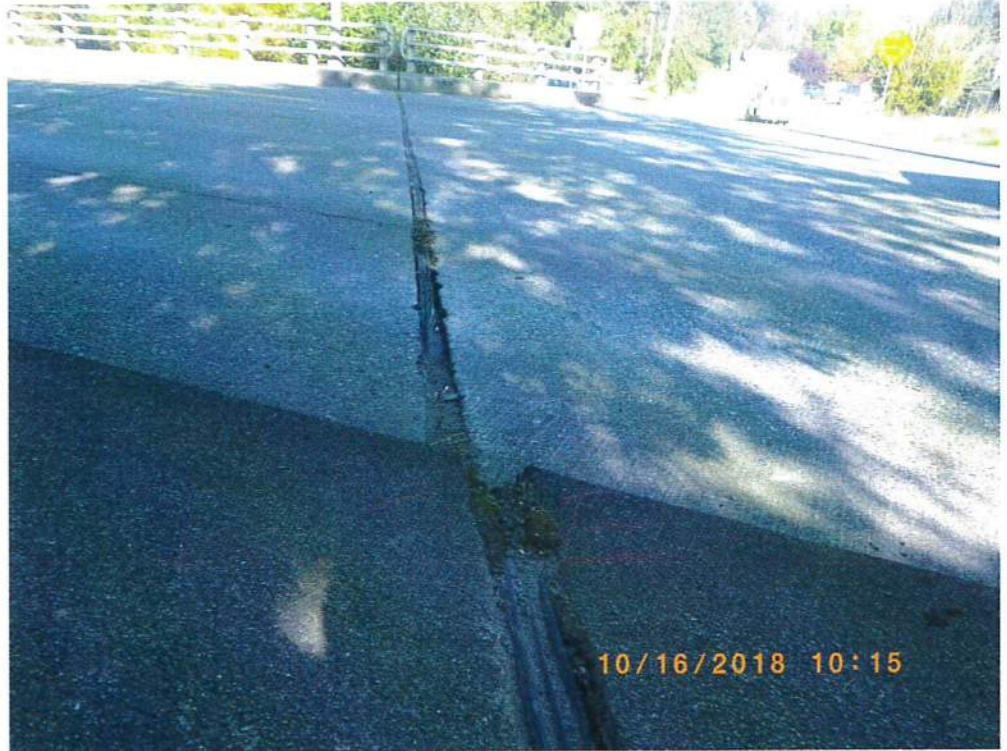
REMARKS: Compression seal is loose
and rolled in joint

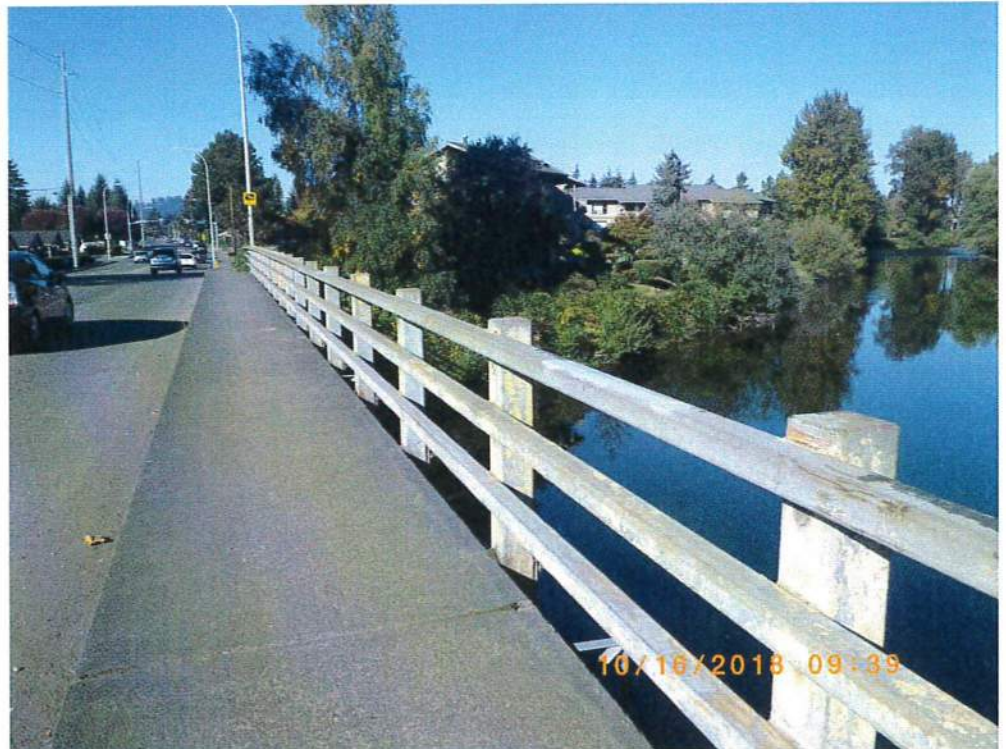
PHOTO: AUB-19
10-16-2018 MAG
(7) SIDEWALK
AND RAILS

REMARKS: Paint failed on rails, areas of
surface rust developing

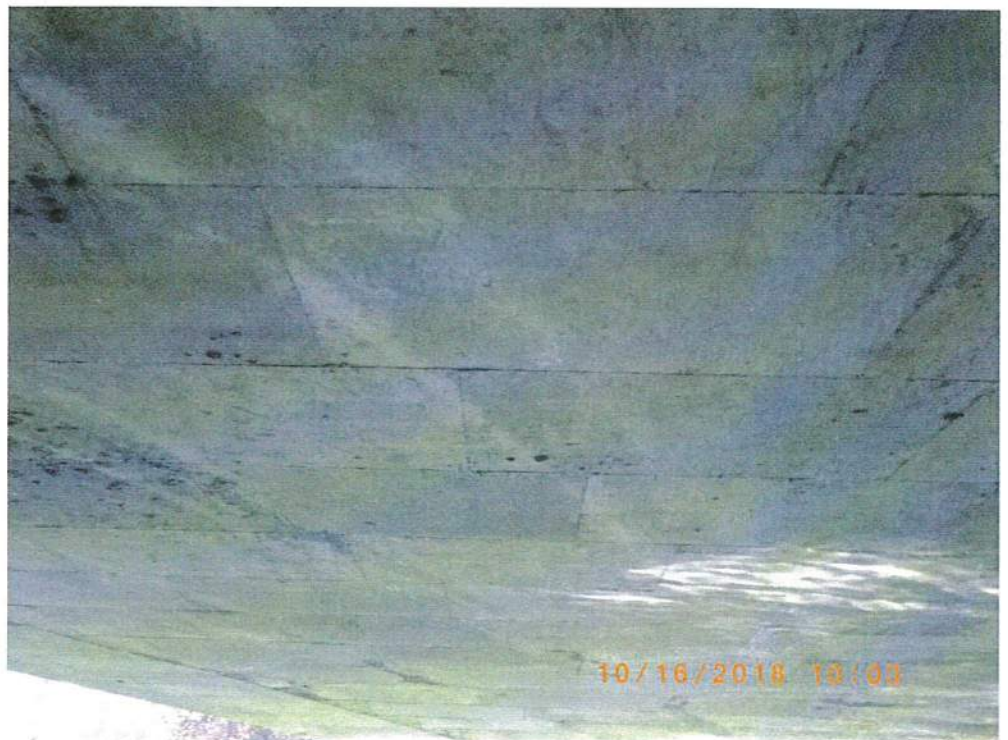
PHOTO: AUB-19
10-16-2018 MAG
(38) BOX
BOTTOM
FLANGE

REMARKS: scattered leaching cracks
throughout bottom flange of box girder

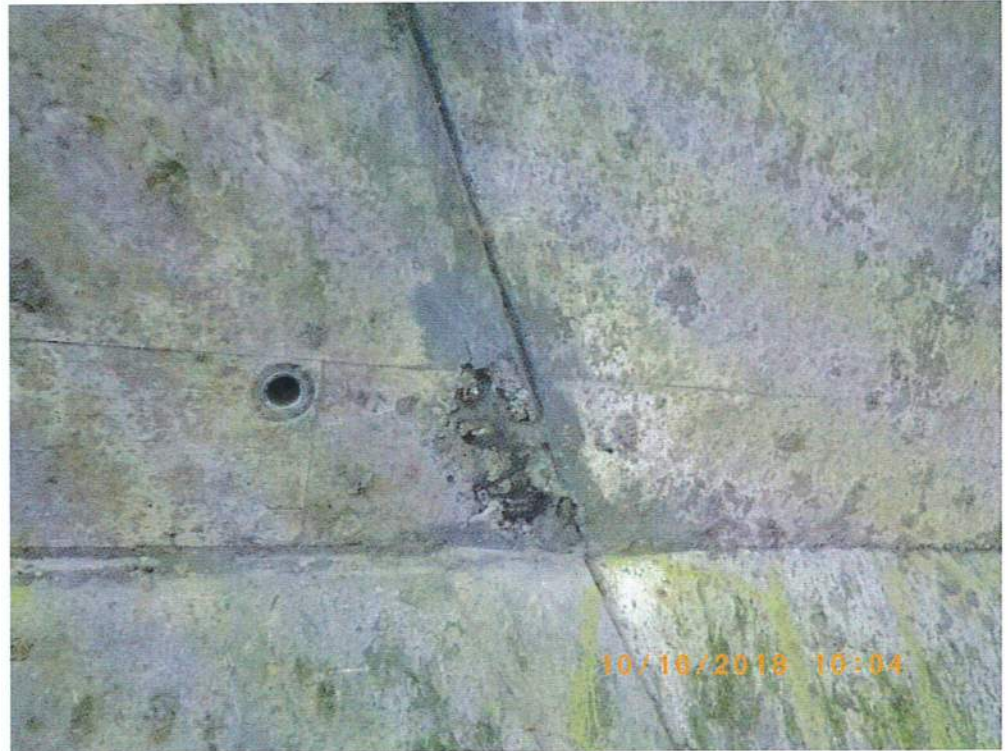
PHOTO: AUB-19
10-16-2018 MAG
(39) BOX SPALL
SE

REMARKS: SE corner of bottom flange
spall with exposed rebar.

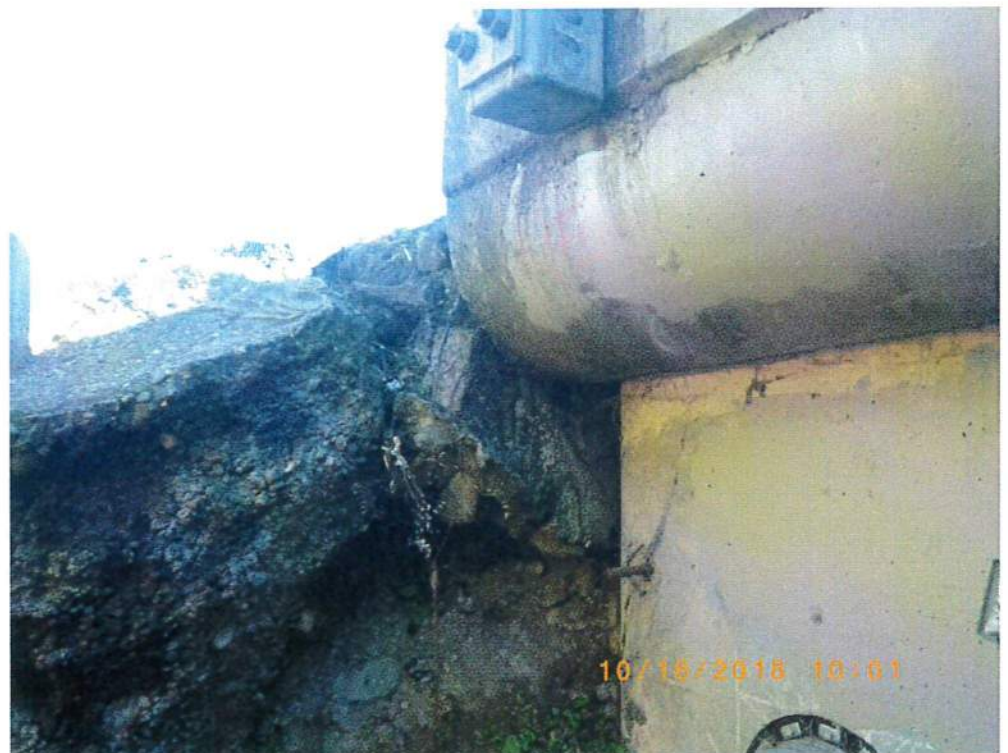
PHOTO: AUB-19
10-16-2018 MAG
(33) NE
SIDEWALK

REMARKS: Sloughing under NE corner
of approach sidewalk at NE retaining wall

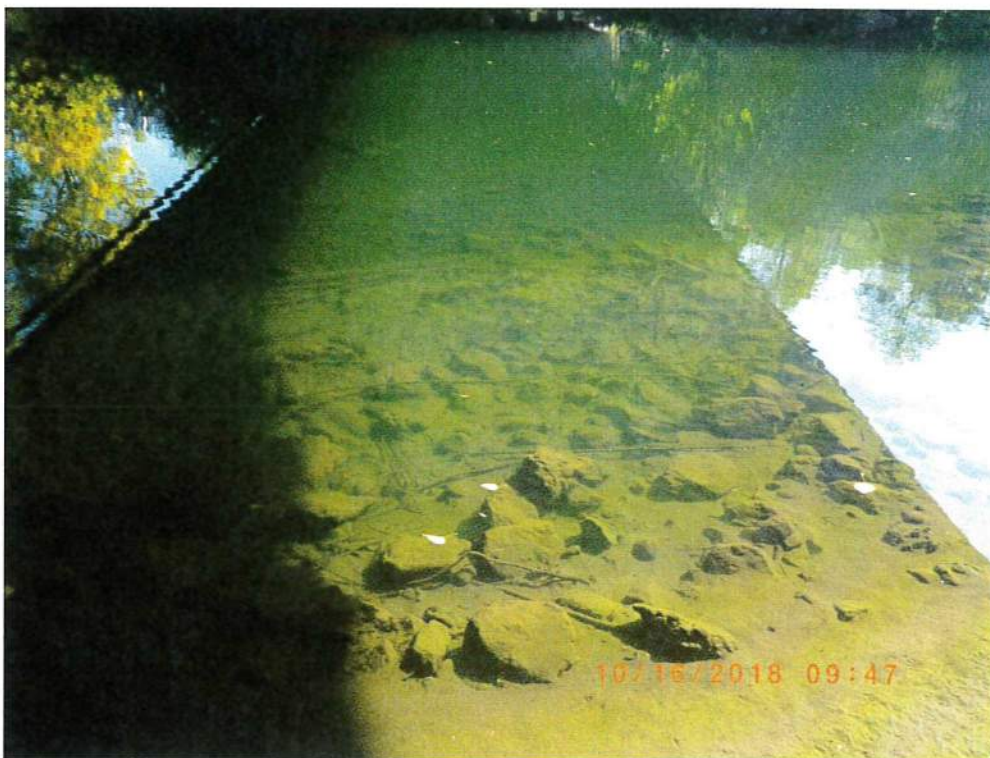
PHOTO: AUB-19
10-16-2018 MAG
(19) RIP RAP

REMARKS: Scattered riprap submerged at abutment 1

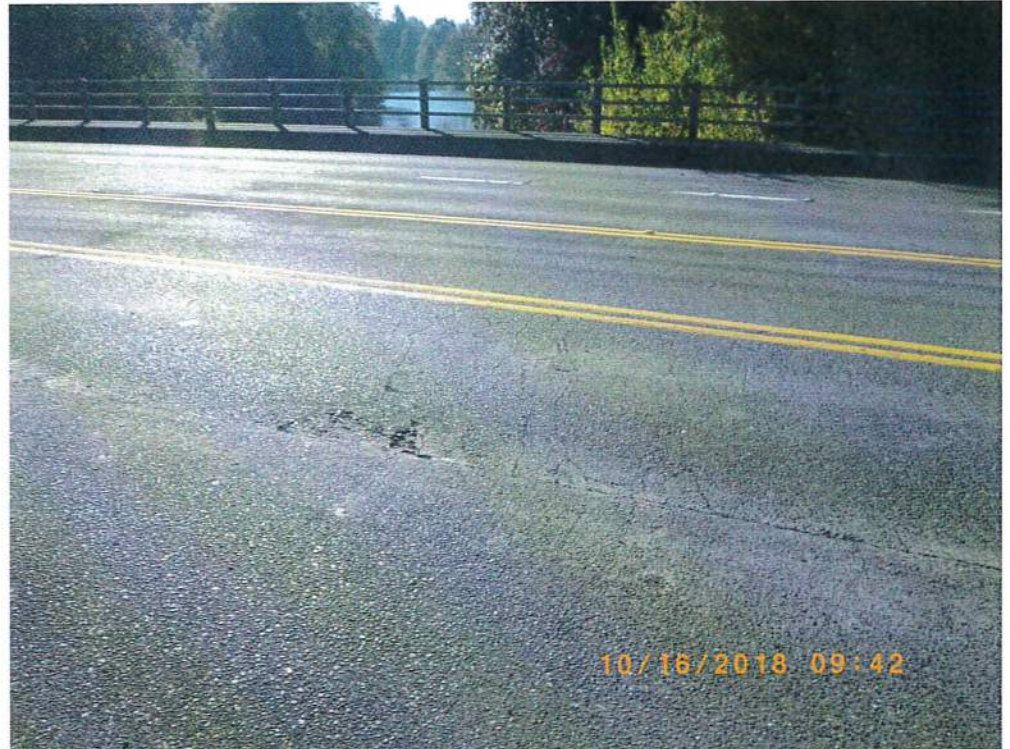
REMARKS: Deck cracks and scaling
along construction joint
